Manhole Inspection Summary

Manhole # S25M__018MH

Insp Date: **3/5/08 12:43 PM**

Location Address: **1110 South Carey Street**

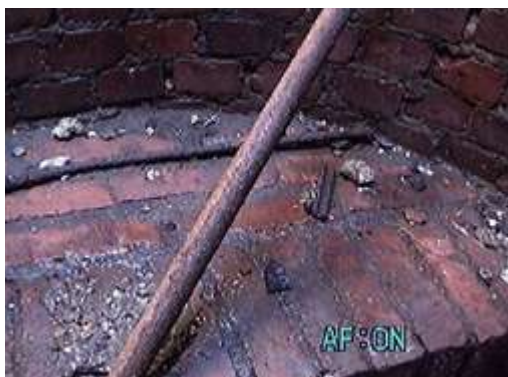
Debris in manhole

debris on the bench

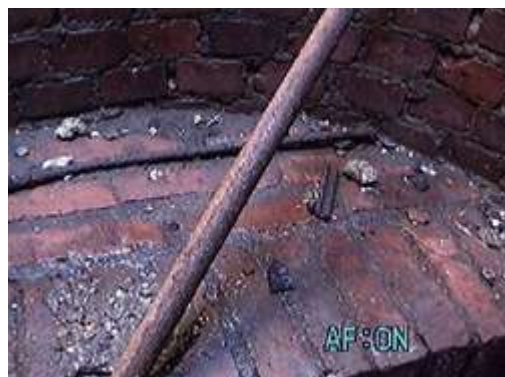
Debris in manhole

debris on the bench

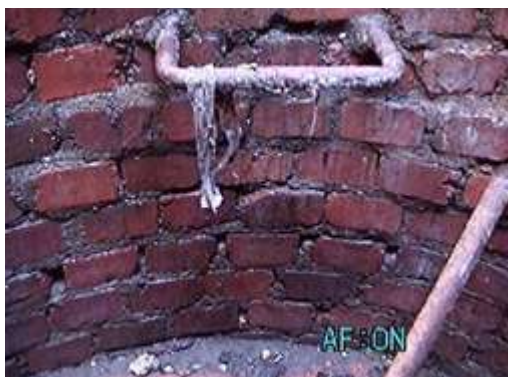
Defect 5

☒ **Evidence Of Surcharge** Depth: **3** (ft.) ☐ Active Surcharge Present

evidence of surcharge on steps

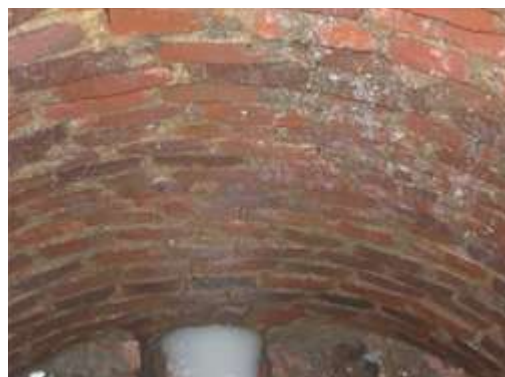
Defect 4

Infiltration: ☐ None ☐ Joint ☐ Cracks ☐ Mortar ☐ Roots ☒ **Wall**

corbel and barrel infiltration

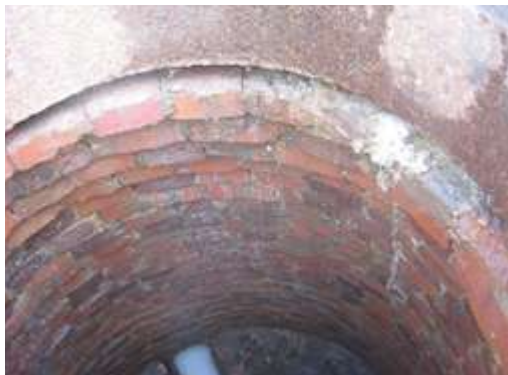
Defect 3

Infiltration: ☐ None ☐ Joint ☐ Cracks ☐ Mortar ☐ Roots ☒ **Wall**

chimney infiltration

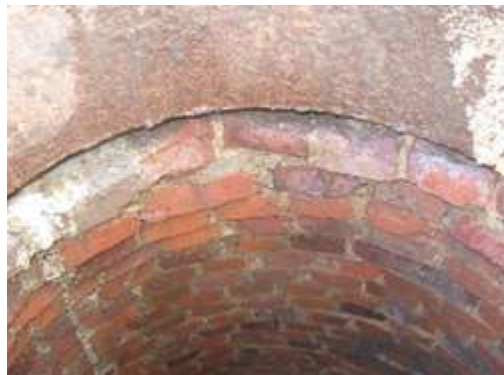
Defect 2

Condition: ☐ Sound ☒ **Cracked** ☐ Root Intrusion ☒ **Loose Brick** ☐ Deteriorated

broken and loose bricks

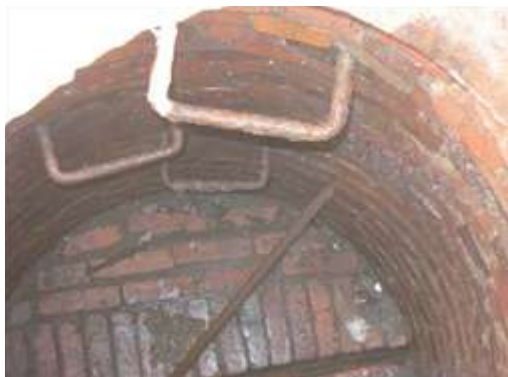
Defect 1

Count: **3** Missing: **0** ☒ **Corroded**

corroded steps

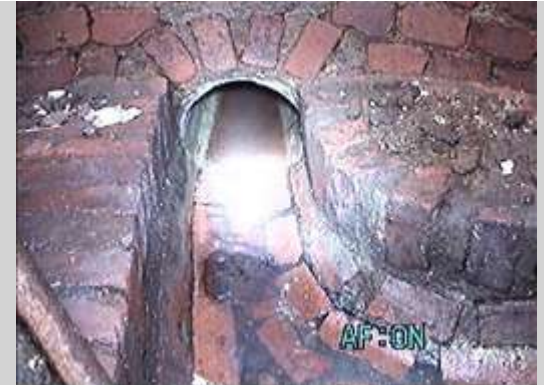
12 O'Clock Outflow

Pipe Height: **8.4** (in.) Rod and Bar (Angled)
Pipe Material: **Clay** ☐ Pipe Lined
Invert Depth: **7.01** (ft.) Flow Characteristics: **Slow**
Deposits: ☒ None ☐ Mud ☐ Sludge ☐ Debris ☐ Grease
Silt Depth: **0** (in.) Deposits Extent:
Infiltration: **Evidence** Pipe Seal Cond: **Unknown**
